# **Deadline 5 Submission on Behalf of the Neighbours and Users of Queen Elizabeth Park**

**Nick Jarman**

Interested Party reference no: **20022545**

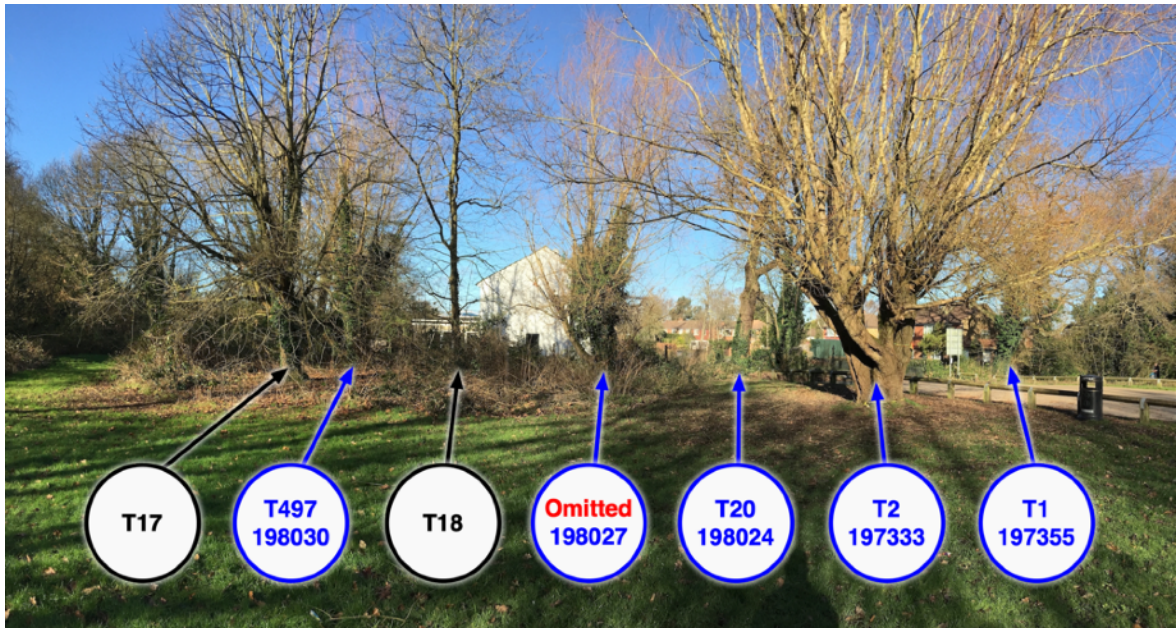
1. Path position near T432 and T433 - these trees are on the other side of the path.
2. T249 is listed as a sweet chestnut but is actually an oak.
3. A Notable Tree within the proposed Cabrol Road construction compound has been omitted.

The image below shows the Notable Tree in the proposed Cabrol Road construction compound. It is listed in the Woodland Trust's ATI as number 198027.

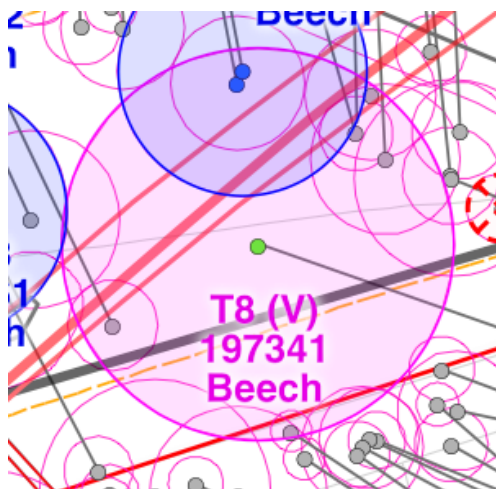
(Extract from sheet 4)

### **The Fairy Tree (T42/S2700-T8-A3 - Veteran)**

The trench (black line running through the RPA) is only 4.7 metres away from the trunk and severs 29% of the root area.

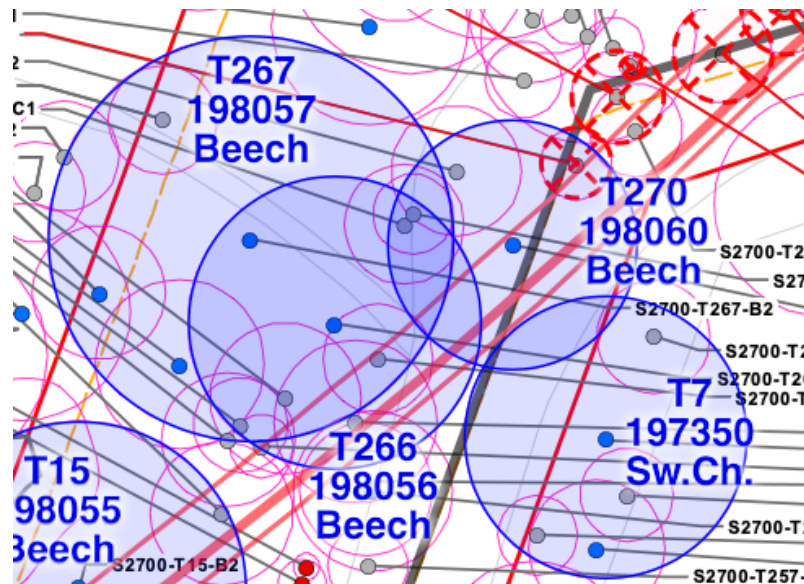
(Extract from sheet 4)

### **Beech S2700-T270 (Notable)**

This tree is critically endangered by the trench, which passes so close to the trunk that it seems impossible that the tree can be retained. We calculate that the trench passes 0.8 metres from the centre of the trunk and severs 44% of its root area. We are deeply concerned that this tree will be removed to facilitate trenching. Whilst we understand that Esso do not currently plan to remove this tree, the DCO gives them the power to do this if needed. We would be interested to hear Esso's comments on this.

This is a particularly congested area where sweet chestnut S2700-T7 (Notable) will sustain damage to the periphery of its root zone and beech S2700-T266's (Notable) root zone is close to the trench. Damage to the latter is a possibility, depending on the exact route of the pipeline and the eventual width of the trench.

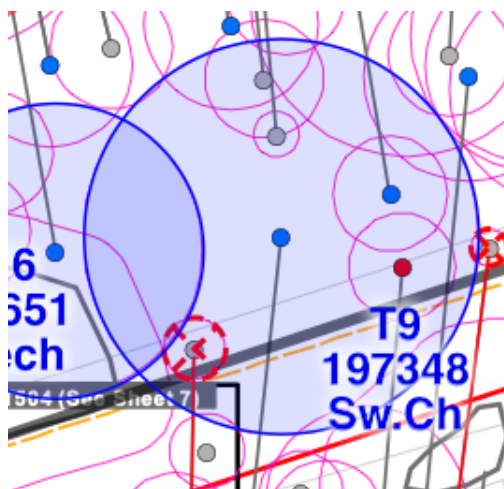
(Extract from sheet 4)

### **Sweet chestnut S2700-T9**

This tree has 20% of its root area severed, with the trench 6 metres away from the centre of its trunk.

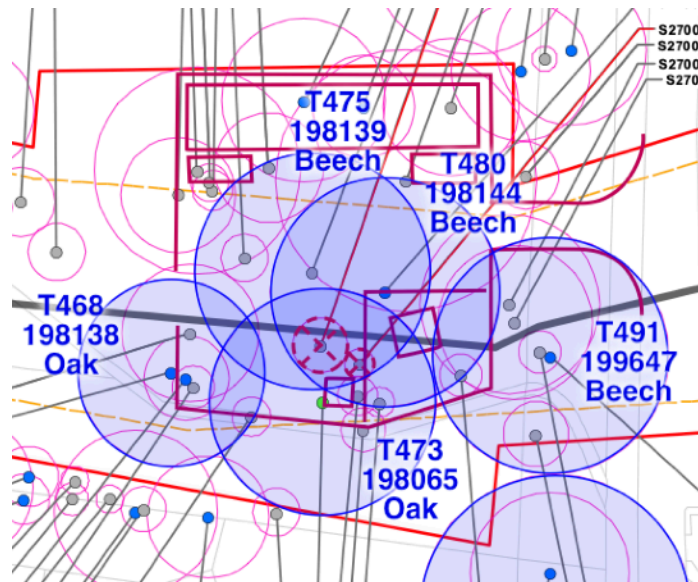
(Extract from sheet 5)

### **Oaks S2700-T468 and S2700-T473 and beeches S2700-T475 and S2700-T480**

These trees are all affected by the trench, having between 16% and 27% of their root areas severed. These are all Notable Trees. The added complication for this group of trees is that they are in the auger boring compound and will be exposed to other threats described in subsequent sections.

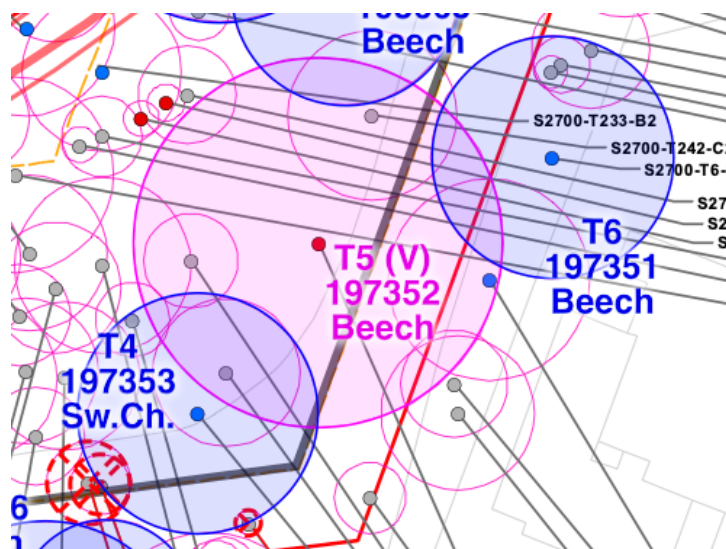
(Extract from sheet 3)

### **Veteran beech S2700-T5 and sweet chestnut S2700-T4 (Notable)**

The Veteran beech has 32% of its root area severed, with the trench 4.2 metres from its trunk whilst sweet chestnut S2700-T4 (Notable) has 20% severed. Beech S2700-T6 (Notable) is just outside the trench area but at risk depending on the actual extent of its roots and the final path of the pipeline.

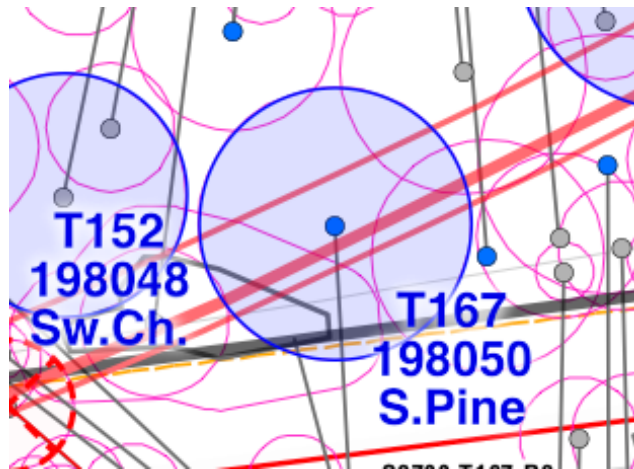
(Extract from sheet 2)

**Scots Pine S2700-T167 (Notable)**

This tree has 7% of its root area severed and will be further stressed by stringing activities (see section 2.4):

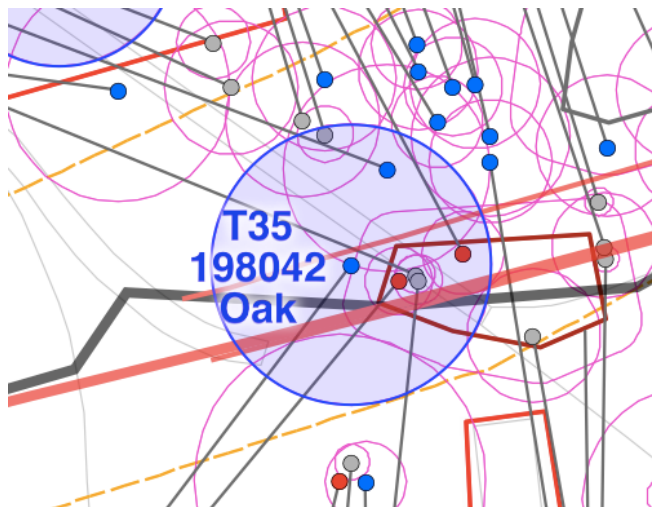
(Extract from sheet 1)

**Oak S2700-T35 (Notable)**

This tree is in grave danger because of the proximity of the trench to its trunk. 34% of its root area will be severed as the trench passes 2.5 metres from the centre of its trunk.

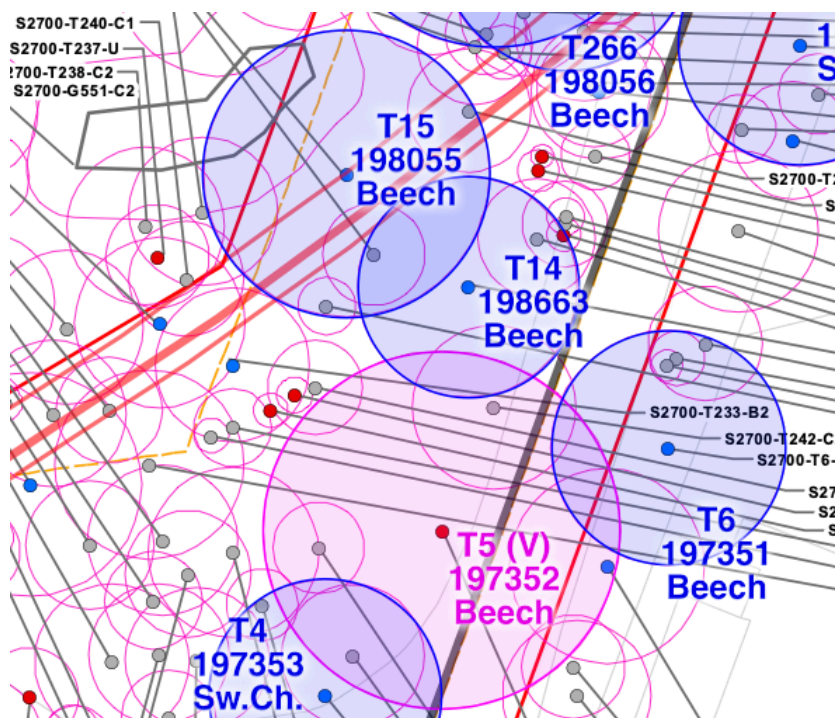
(Extract from sheet 3)

## Blocker 1

Beeches S2700-T15, S2700-T14 (both Notable) and Veteran beech S2700-T5 span the Order Limits. Beech S2700-T6 also forms part of this group.

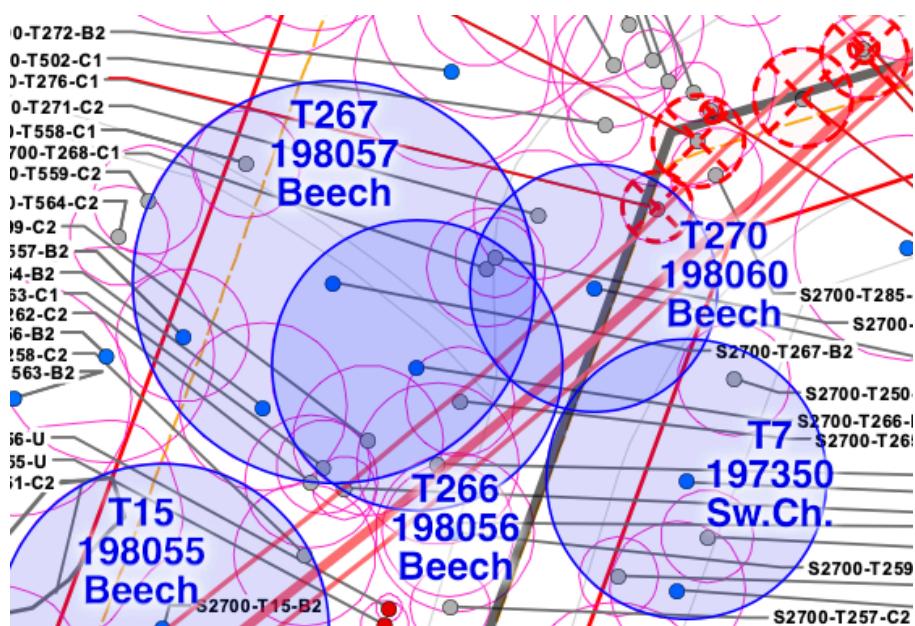
(Extract from sheet 4)

## Blocker 2

Beeches S2700-T267 and S2700-T270 (both Notable) span the Order Limits, with beech S2700-T266 (Notable) and sweet chestnut S2700-T7 (Notable) contributing additional cover.

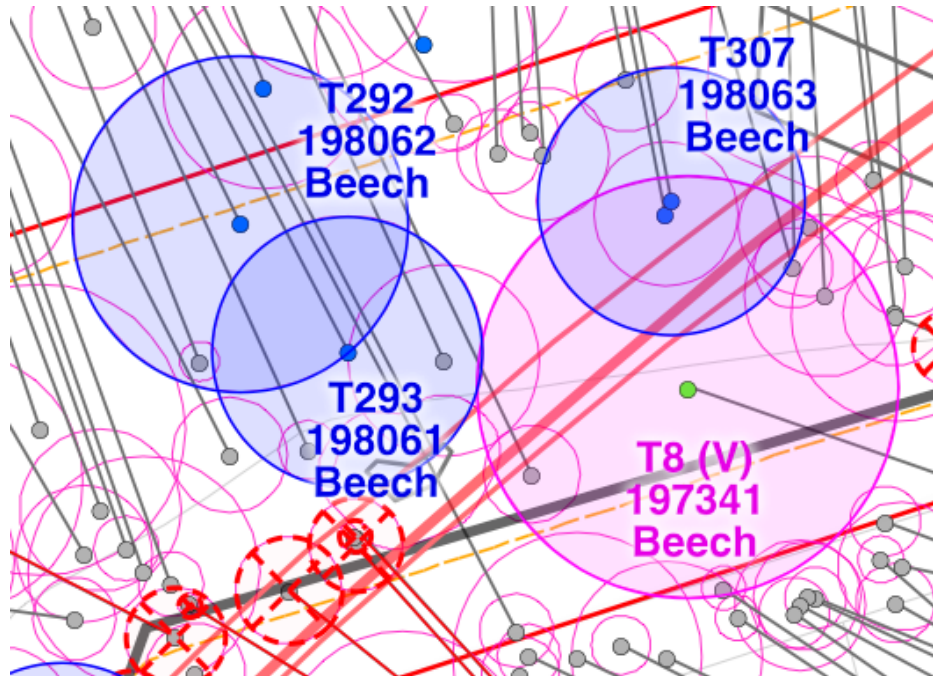
(Extract from sheet 4)

### **Blocker 3**

The Fairy Tree (T42/S2700-T8, Veteran) is in a group which also spans the Order Limits, with the help of beeches S2700-T293 and S2700-T292 (both Notable). Also in this group of trees is beech S2700-T307, which although it does not reach the edge of the Order Limits, does cover the Limits of Deviation.

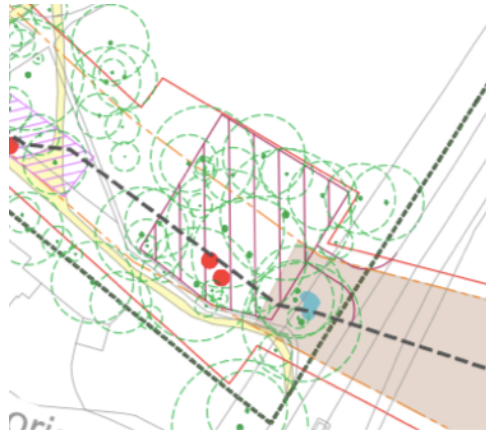
Previous drawings have shown the reception pit being located within the compound, however the 'pond' is outside the compound, as shown in the diagram below (from the QEP SSP):

The QEP Site Specific Plan states that the reception pit will be 6 x 5 metres in size and 3 metres deep. Previously the Detailed Trenchless and Targeted Open Cut Assessment<sup>6</sup>, section 1.23, gave the dimensions as 3m x 3m x 6m (deep). No reason is given for the change in size.

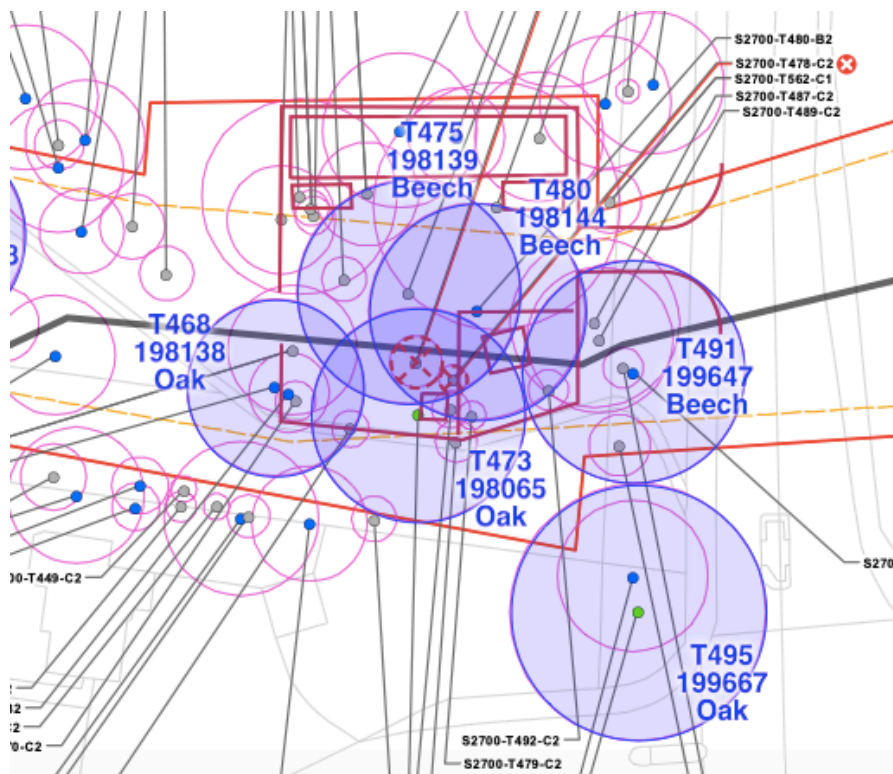
Wherever the pit is located within the compound, excavating it will cause the loss of many of the trees due to the destruction of their root areas. There may be no intention to remove the trees before work starts, but the amount of roots damaged by the work will be significant.

This is one of the densest areas of Notable Trees in the park, containing S2700-T475, S2700-T480, S2700-T468, S2700-T473 and S2700-T491 as shown above.

Esso's claims that a 6m x 5m pit can be excavated, that the proposed compound can be built and that both can be operated at this location without the loss of trees do not seem remotely credible.

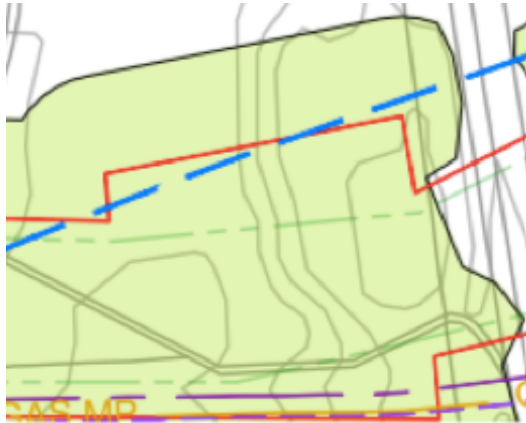
There is one map extract which helps to illustrate this, taken from page 9 of Esso's Responses to ExA's Further Written Questions - Queen Elizabeth Country Park, which shows the contours in the area. Unfortunately this map is small and lacks any contour labels so the elevations they represent are unknown (though we estimate they are 1 metre lines).

It is hard to imagine this being a safe working area without significant grading and levelling of the surface before any work can start.

This area is also covered in trees, many of which are Notable. It will be impossible to raise or lower the soil level around the trees and roots without significant damage to the trees. The area cannot be levelled to allow a working area for vehicles, or as a basis for digging a pit.

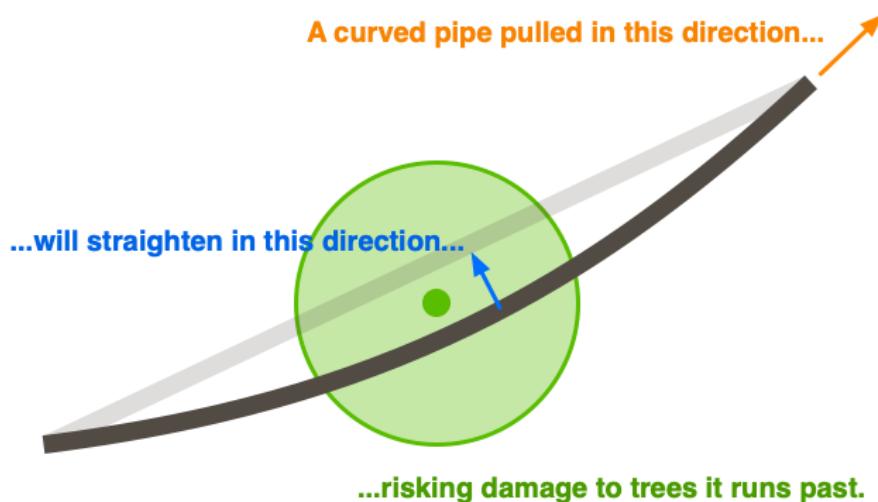
During both pulling operations, forces exerted on the pipe string will cause the string to straighten. Any trees on the inner edge of a straightening curve are at risk of damage.

Control and containment of these straightening forces is critical where the proposed string runs close to any tree. We understand that guides and blocks will be used to counteract these forces but we are still particularly concerned about specific Notable and Veteran Trees.

Beech S2700-T188 (Notable), beech S2700-T15 (Notable), beech S2700-T270 (Notable) and beech T42/S2700-T8 (Veteran) are all at significant risk of damage as the pipe attempts to straighten during pulling.

Unless the guides for the pipe string are properly anchored near these trees, there is a risk that the pipe string will collide with the trunk of the tree during pulling. In the best case, the bark will be lightly abraded but there is a realistic risk of greater damage. The worst case is that the tree is pulled over and uprooted.

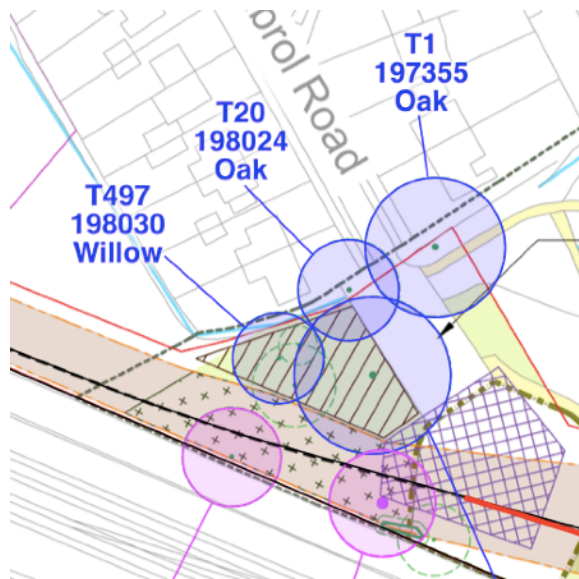
The area of the proposed Cabrol Road construction compound is contained within the root protection areas of three notable trees: oak S2700-T20 (Notable), willow S2700-T2 (Notable) and willow S2700-T497 (Notable).

The root protection areas of these Notable trees cover nearly all of the proposed compound area (95%). The following activities should not be undertaken within the compound due to the root protection areas of the Notable trees:

1. Stripping of topsoil in preparation for the compound surface to be installed.
2. Storage of topsoil from the compound surface or elsewhere on the site.
3. Any activities which would lead to soil compaction.

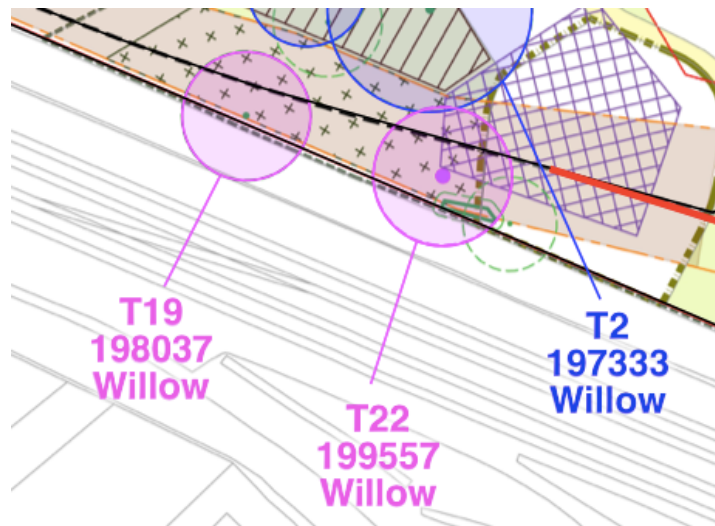
The HDD bore for TC018 passes through the root protection areas of two Veteran Trees. These are both willows, S2700-T19 and S2700-T22 (previously identified by Esso as T41).

Both trees are at risk due to the HDD bore rising up through their roots to the reception pit. T22 is most at risk, whilst the potential damage to T19 is unclear without knowing how deep the bore will be as it passes beneath the tree. A sectional diagram showing the bore and trees in this section is needed from Esso.

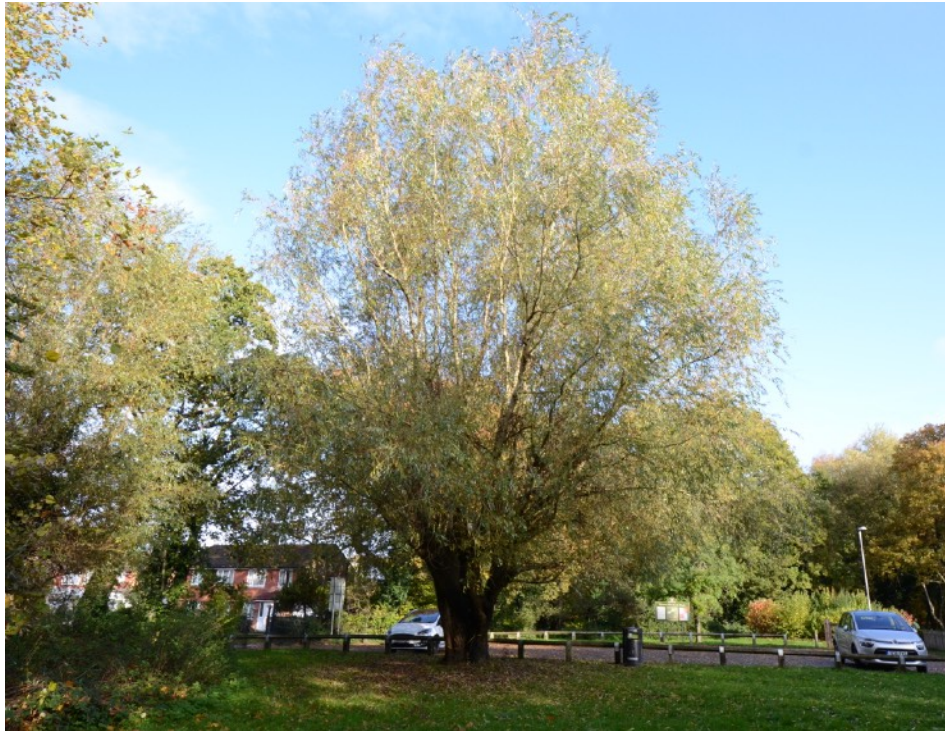
Branch lopping would destroy the character of many trees in the park, but in particular the willow T2700-T2 (Notable), which covers most of the area of the proposed construction compound, would lose its pleasing distinctive and symmetrical shape.

Willow T2700-T2 should not be lopped.

We also suggest that Esso should revise the compound boundary to avoid root protection areas of these notable trees and make better use of the open space where the play area is located.

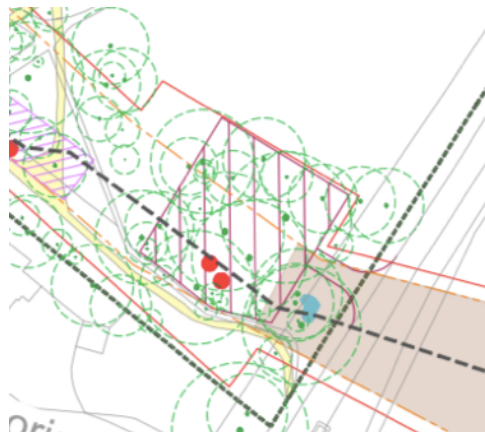
As stated in the previous section, the water body is outside the proposed compound. This is shown in Appendix B of the QEP SSP:

We would like to clarify that there is no wildlife pond on the eastern side of the park. There is a dip in the ground which collects water during heavy rain, but it is not a wildlife pond.

We request that Esso do not build a pond in the park and are confident that Rushmoor Borough Council, as the land owner, will not permit this.
