Deadline 7 Submission on Behalf of the Neighbours and Users of Queen Elizabeth Park

Interested Party reference no: **20022545**

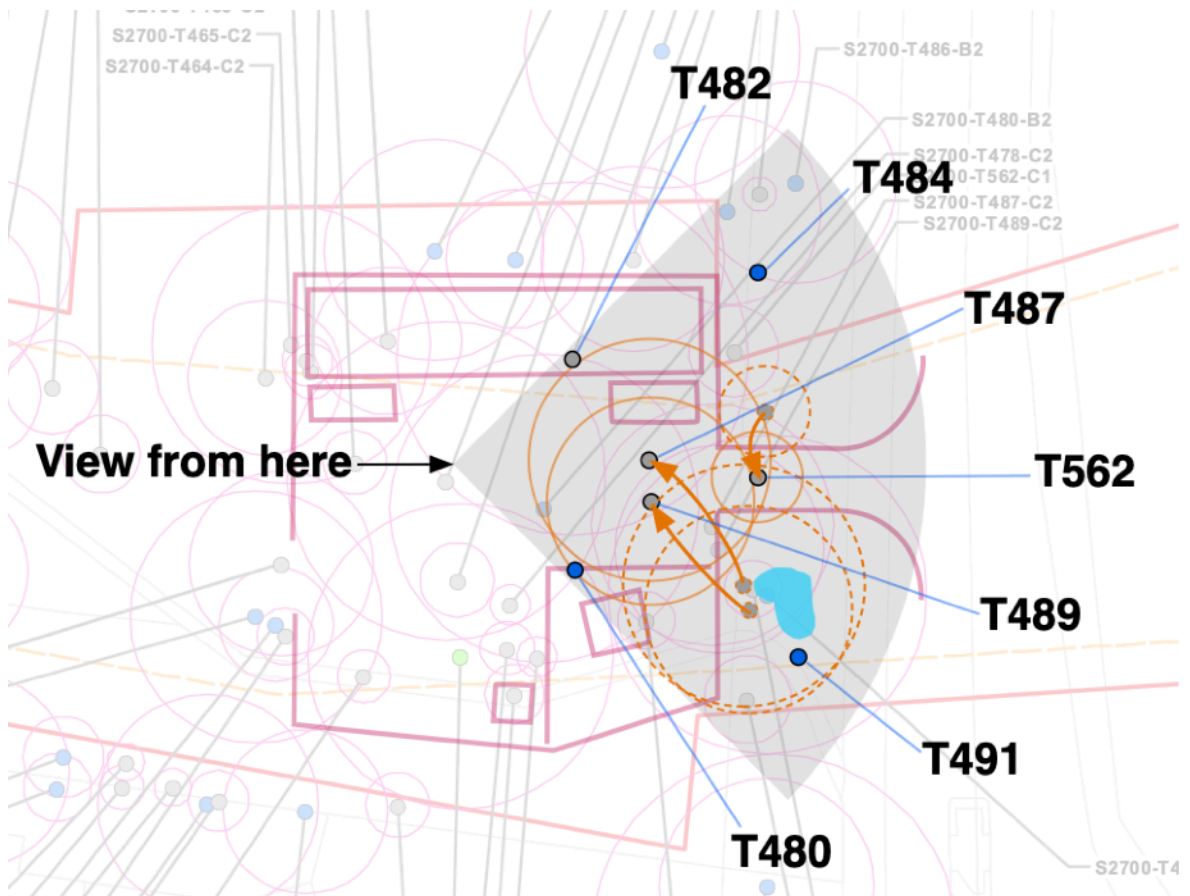
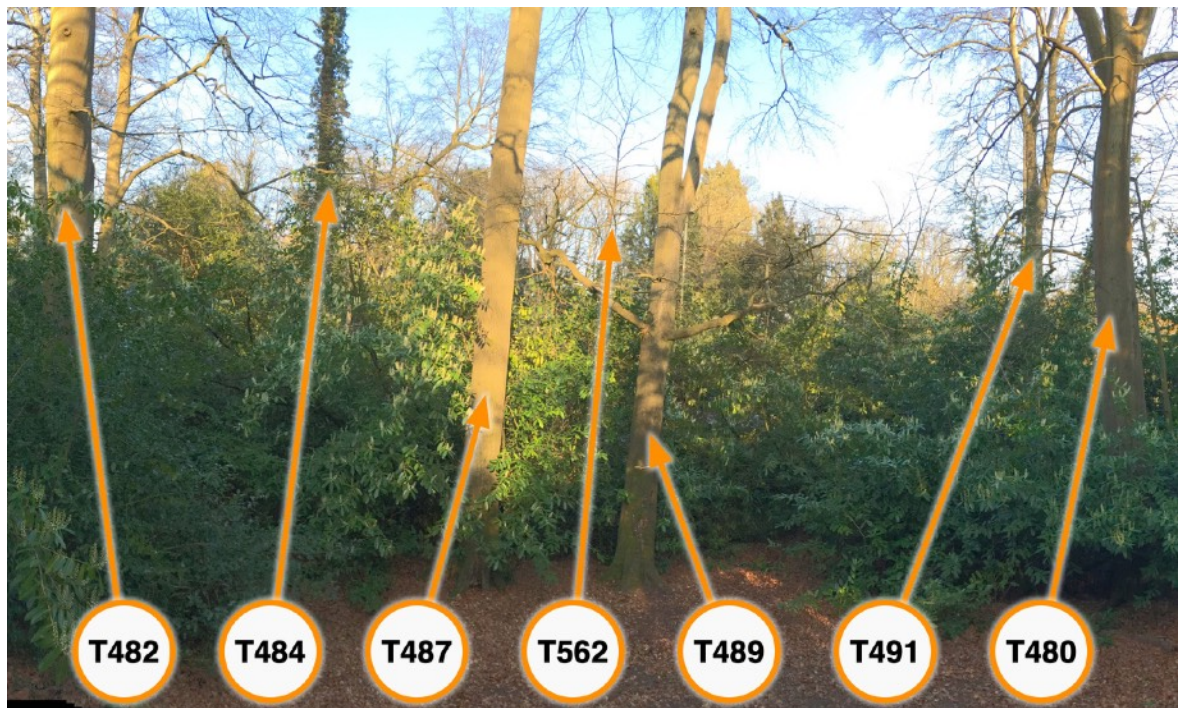
We have concluded that some trees are not shown in the correct place, namely T487, T489 and T562. As evidence of this, we present a photograph taken from a known point, with trees from Esso's survey labelled. It should be evident that Esso's plan cannot possibly be an accurate representation of this view because if it were, T487, T489 would appear almost in line with T491.

Our amendments to the drawing show the more likely positions of these trees. We note that all three trees would obstruct the proposed entrance and access ramp for the compound.

Corrected tree positions: T562 (sycamore), T487 (beech) and T489 (beech) are not correctly located on Esso's map. Dotted orange lines show the position on Esso's tree survey, solid orange lines show roughly where the trees actually are.

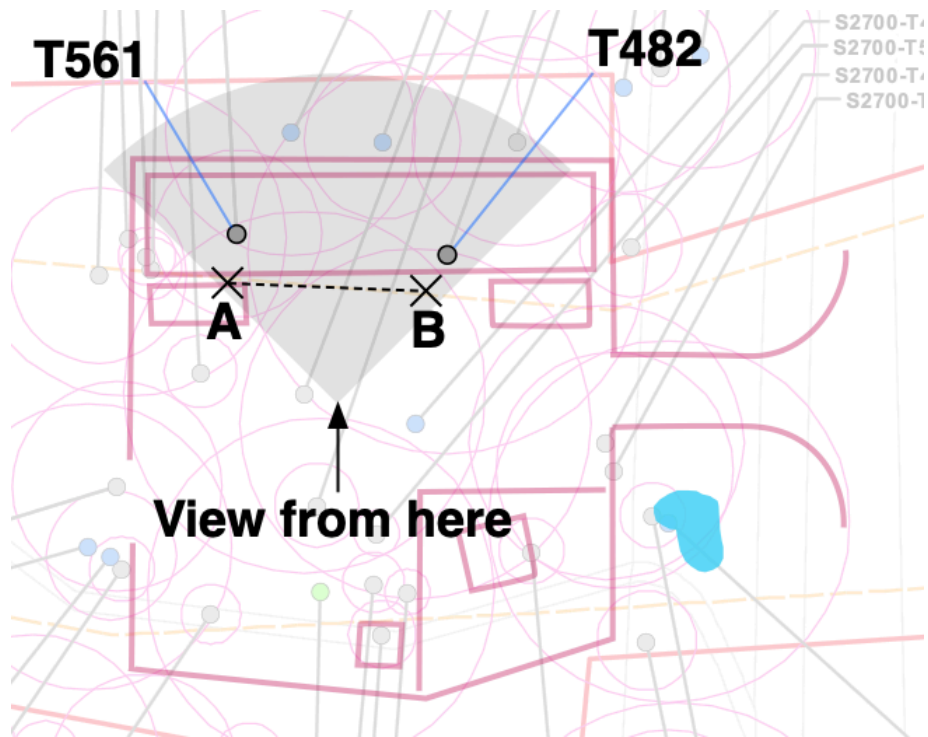
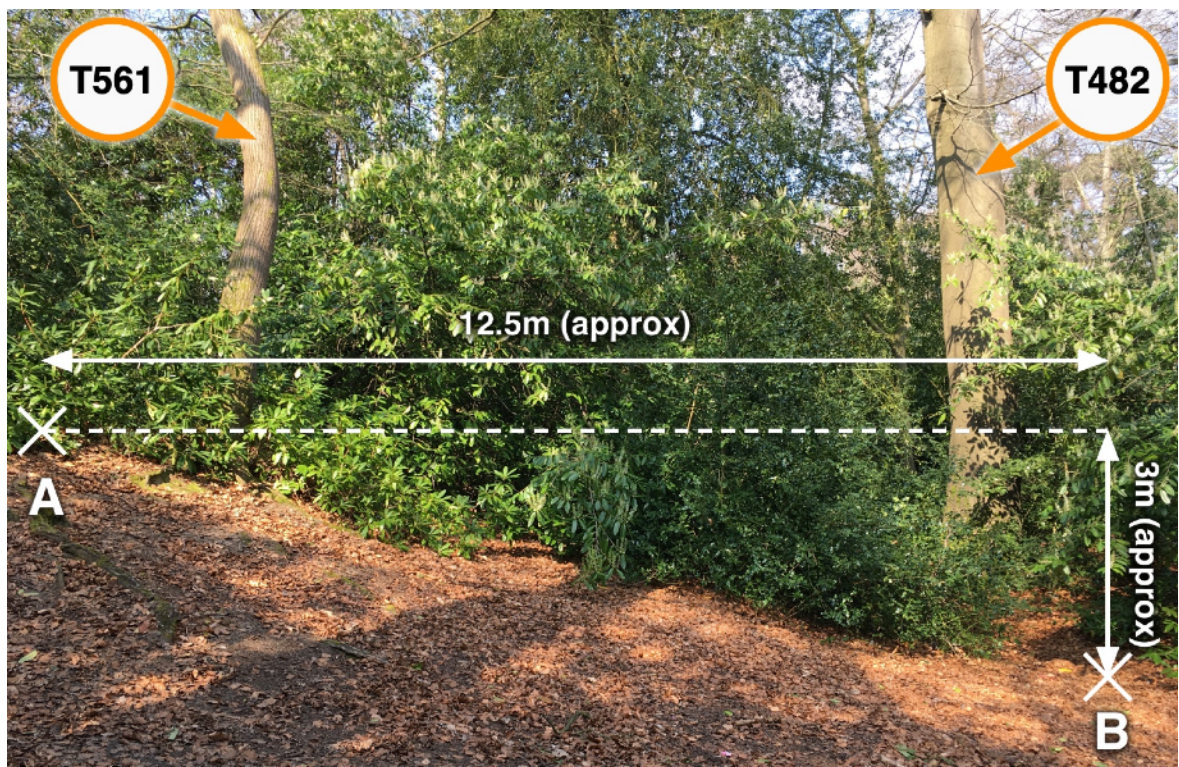
The drawing and photograph below attempt to give an impression of the gradients within the proposed auger boring compound. The photograph shows the difference in ground levels between points A and B in the plan. This is by no means the steepest gradient in the area but it is the easiest to photograph. The gradient between these points is approximately 24% but there are areas with gradients of 35% and more.

It would have been useful if Esso had submitted a topographical survey of the area to the examination to show that their plans are feasible. In the absence of this information, and with our knowledge of the site, we conclude that the survey has not been provided because it would prove that Esso's plans for this area, with the stated level of tree retention, are not feasible.

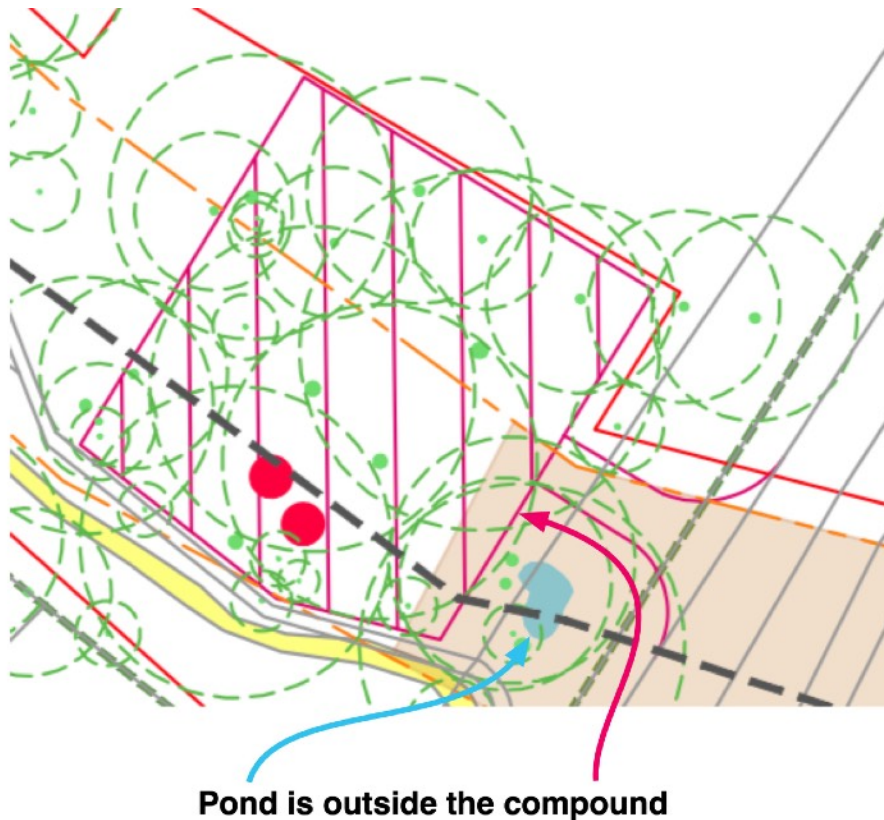
Note that the pond (blue area) is outside the pink hatched area which the key describes as ‘area for auger boring activities’. This means that the pit would be outside the compound and therefore not protected by being enclosed by it. Furthermore, the compound fencing would prevent machinery from accessing the pit area.

The reasons for enclosing such a large area within the compound, when gradients and tree cover mean it cannot be used for any activities, are unclear. There is no explanation as to why the pit is outside the compound.

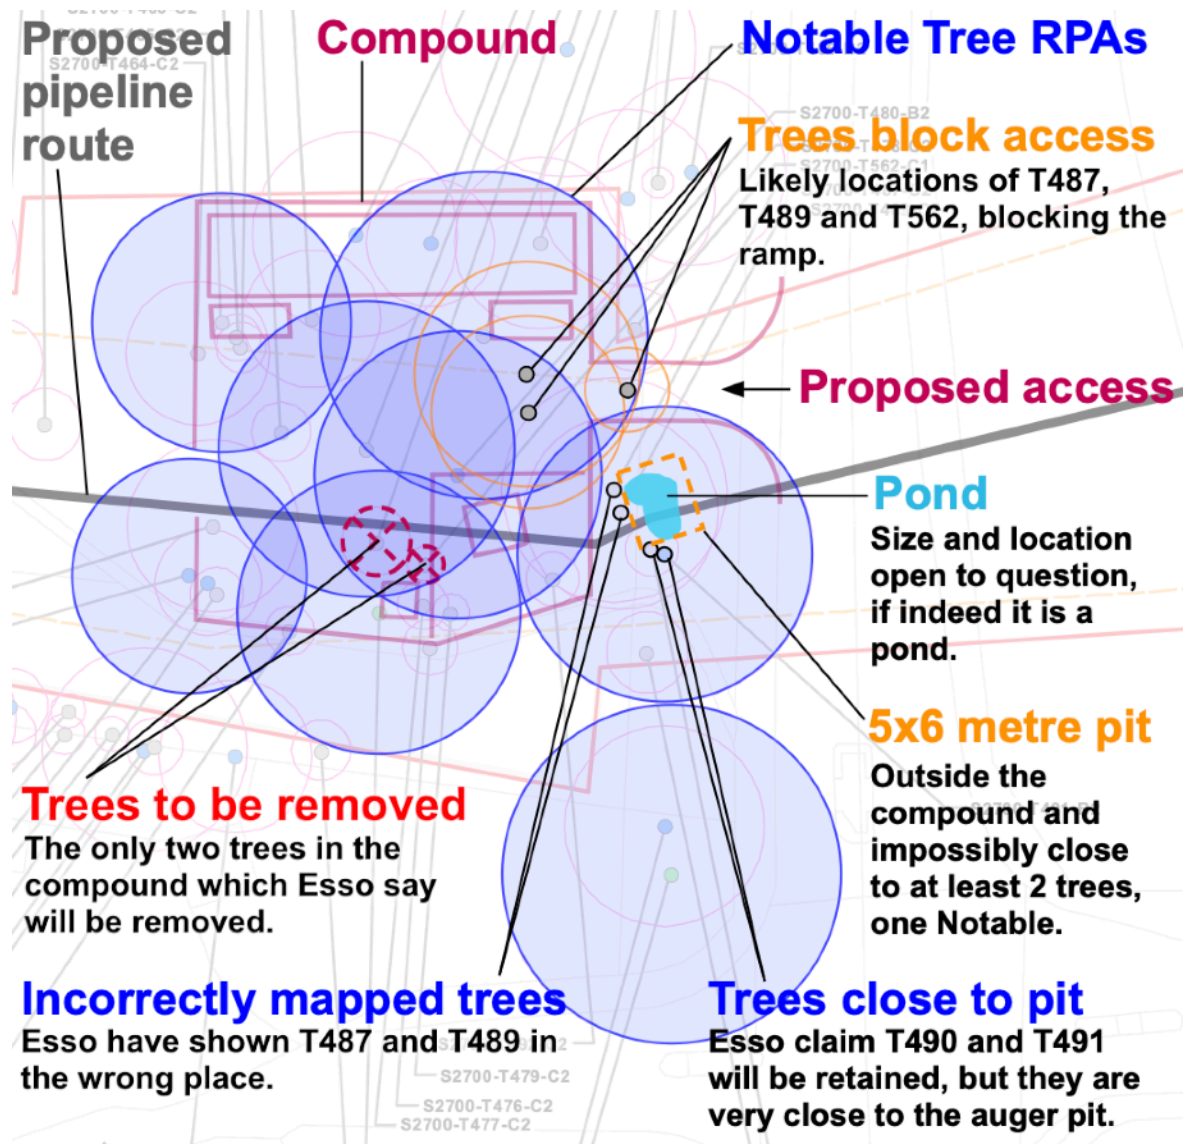
The entire area is still very badly thought out and poorly documented. The information presented by Esso to the Examination does not make sense.

The diagram above is based on the tree survey drawings in the QEP SSP and attempts to show some of the main issues with the plans and proposals provided by Esso.

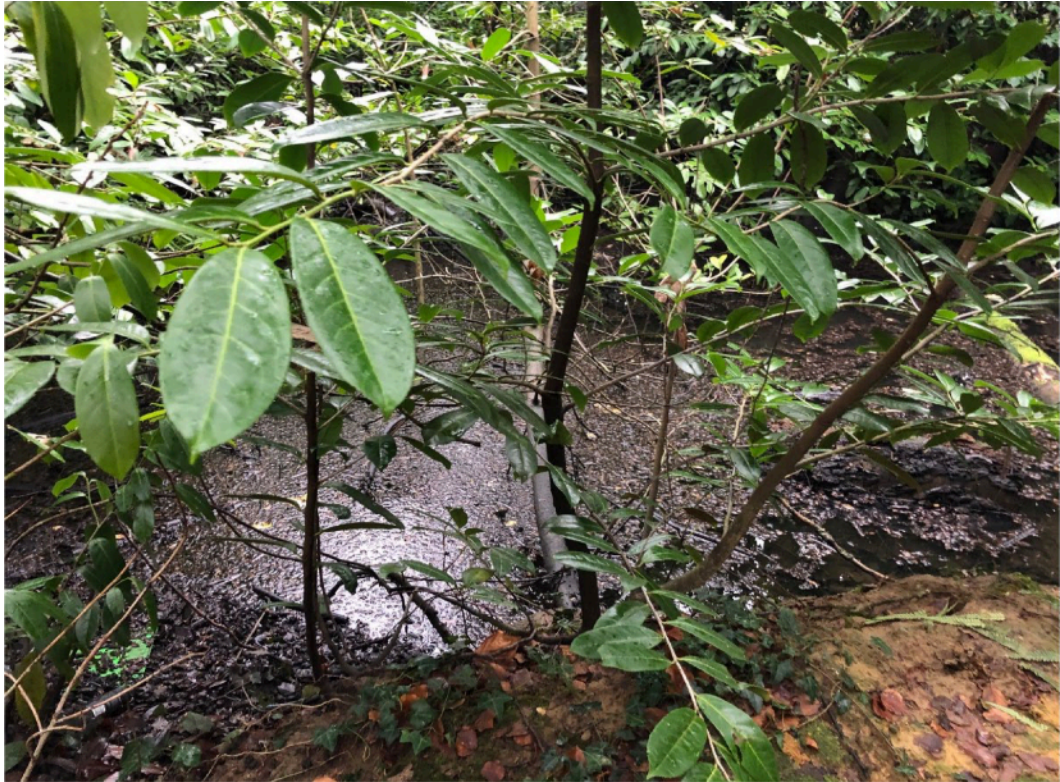
Esso's picture, taken in January 2020¹¹

Esso submitted a photo to support their claim that this is a pond but we can prove that it is not. We visited the same area in March 2020 and found no water. The ground was firm with a covering consistent with a woodland floor and no evidence of aquatic plants of any kind. This is not an ephemeral pond.

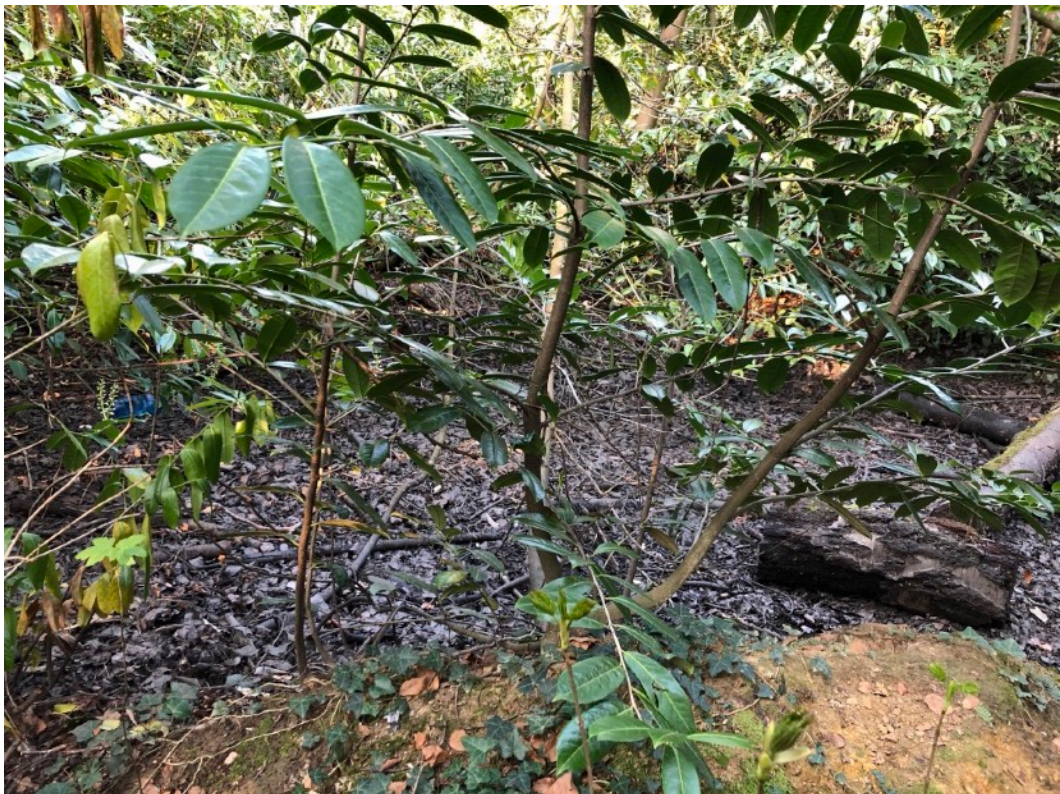
Our picture of the same area, taken from the same position in March 2020

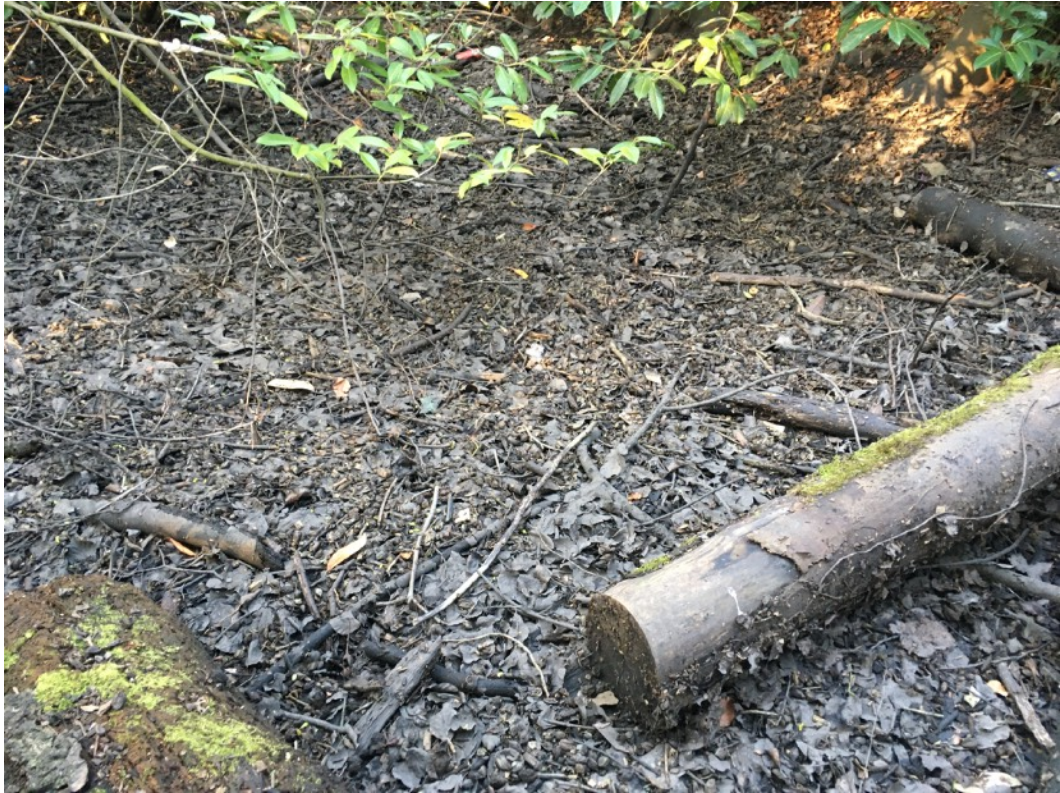
Additional picture of the area where the water collected

We estimate that the maximum depth of the water that Esso saw was between 50mm and 75mm. This is all that accumulated during one of the wettest spells of weather for a number of years. The leaves and other debris show no signs of being submerged beneath water for any significant length of time.

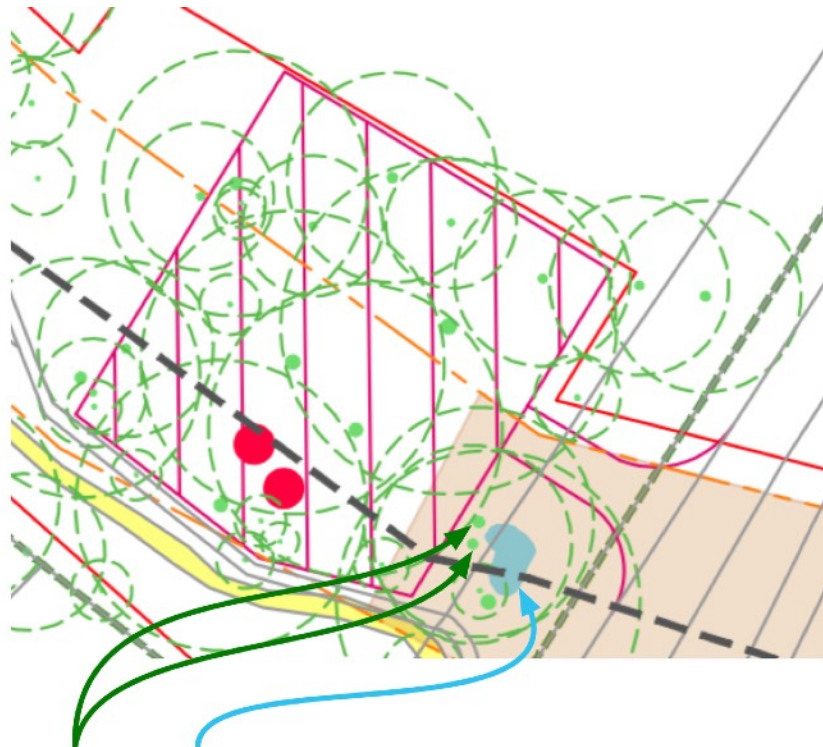
The construction phase drawing in the SSP (extract below) shows the water body/ depression adjacent to T487 and T489 (unlabelled on this drawing but numbers are obtained from the tree survey drawings):

Trees or pond are incorrectly positioned in the drawing

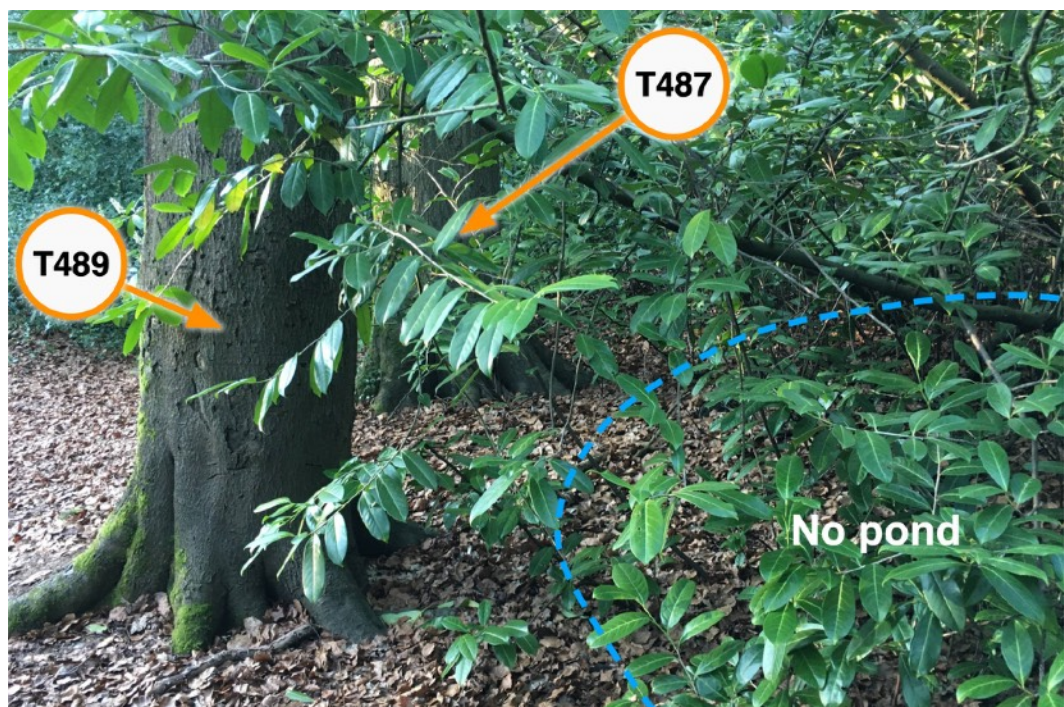
Standing on site and checking this visually, there is no depression or pond adjacent to T487 and T498. Based on this, we believe that not only are the trees drawn in the wrong location (see section 2.2), but the pond/depression is also drawn in the wrong location.

Pond and/or trees not shown in the right place

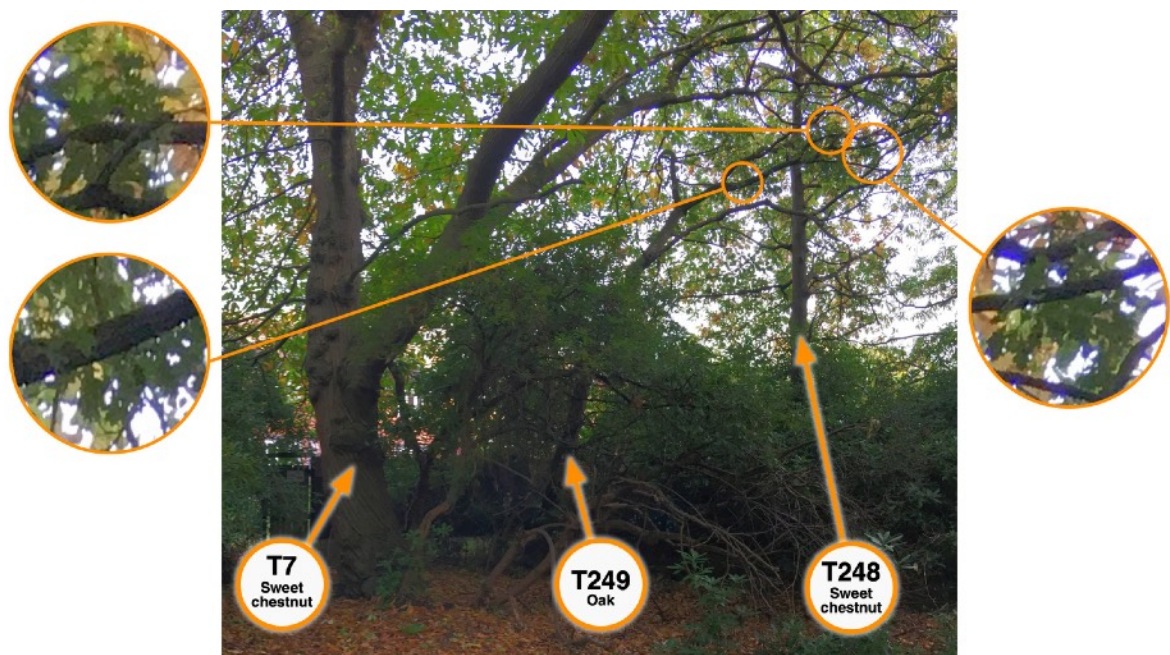
It is difficult to know how best to respond to this. We are extremely familiar with this area of the park. We have also studied Esso's tree survey and drawings in detail to make absolutely certain that we are confident in this assertion: T249 is an Oak.

The photograph below is the only recent picture we can find of T249 when it is in leaf and therefore provably an oak. It was taken in October 2018. We have done the best we can to highlight identifiable oak leaves in the picture but are limited by the low resolution of the picture.

The distinctive oak leaf shape can be seen in the magnifications

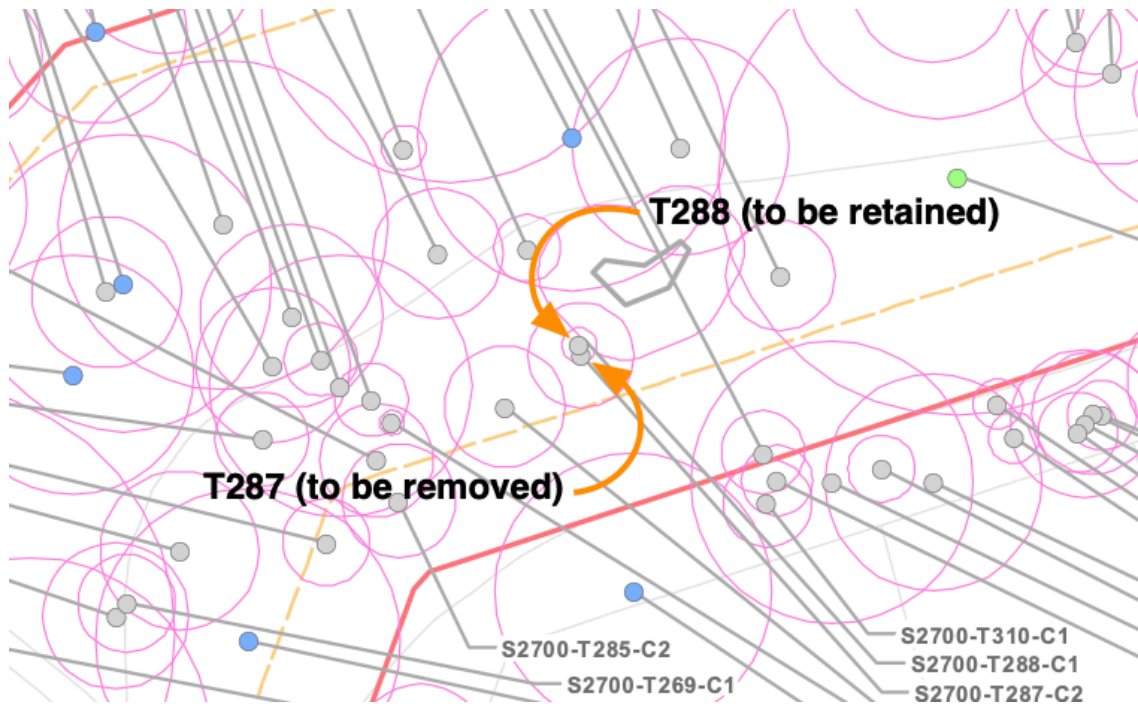
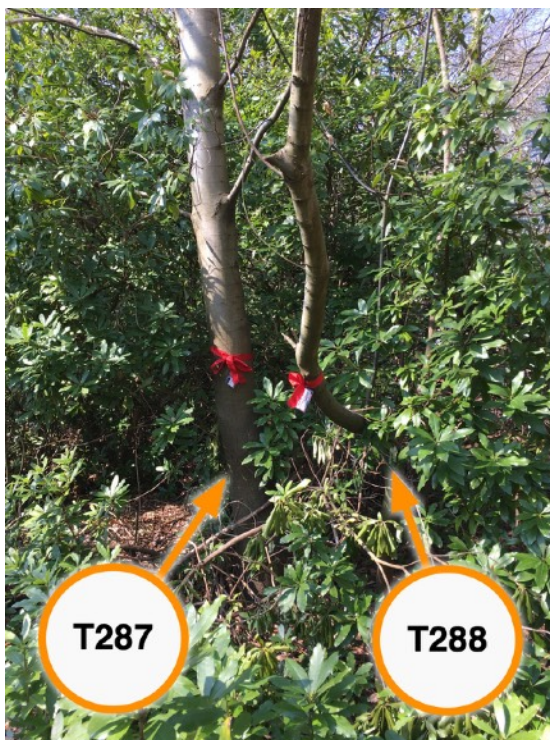
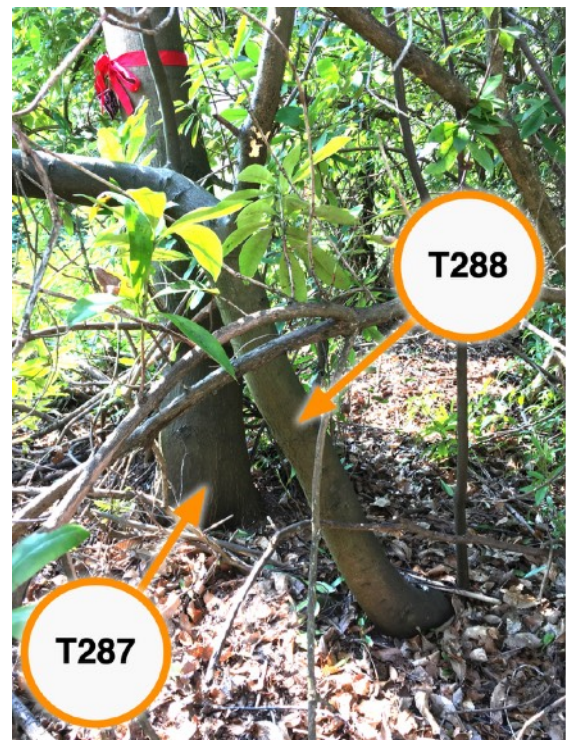
We have doubts about Esso's ability to state so confidently that only those trees which they have listed will be removed. We can show that trees which they claim will be retained are likely to suffer serious damage when their neighbours are removed.

For example, we are somewhat surprised that Esso believe T288 can be retained and not damaged by any works which necessitate the removal of T287 given its proximity to T287. The diagram and photographs below show why this seems hard to believe and leads us to question the commitment on 30 trees.
